Sites 11.5 and 12, at Phoenix Rolff Lake and Site 13 as a reference site on Dry Creek

Site Dry Creek at bridge (DC-13)

Site Ph 11.5 Just below the Phoenix Rolff Lake NPDES discharge point

Site Ph12 Phoenix/Rolff Lake discharge just above confluence to Dry Creek

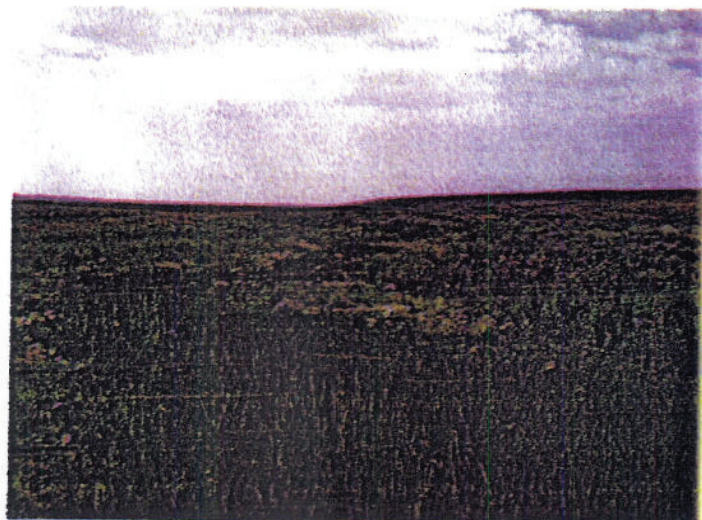
W5-2: From the stock pond at W-5 to the highway and the Little Wind River the stream is ephemeral and only flows during heavy storms and/or spring snow melt.

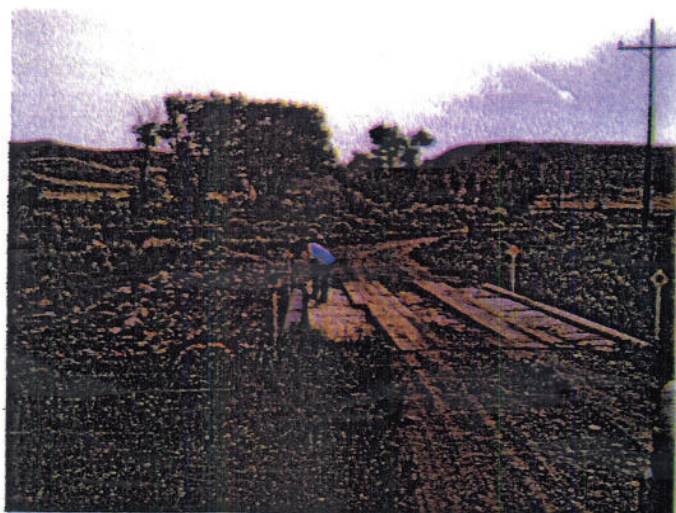
DC13-1: The bridge across Dry Creek on the way to the Phoenix production field marks this background site

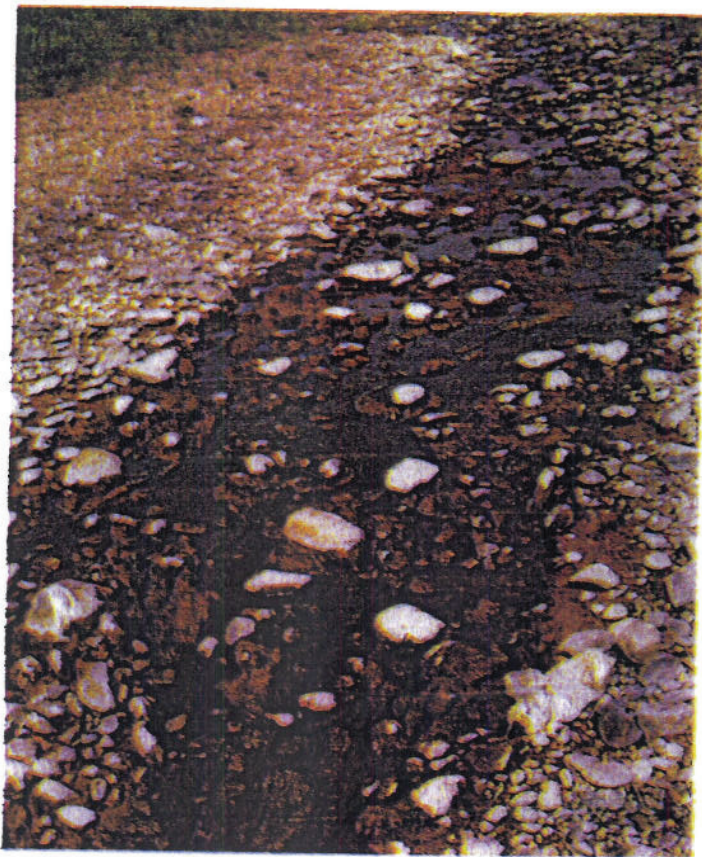
DC13-2: Dry Creek was very low with only a little current between pools. There were still 25 species of macroinvertebrates and large schools of long-nose dace (*Rhinichthys cataractae*).

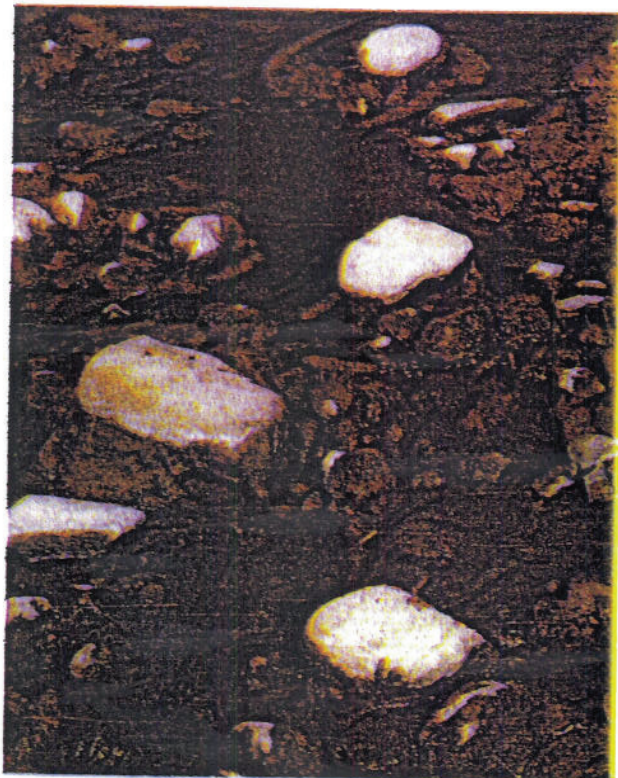
DC13-3: A filamentous alga was prevalent and is indicative of the low flow and higher temperatures that were encountered. The stream is intermittent at the bridge, and ephemeral in the downstream reaches.

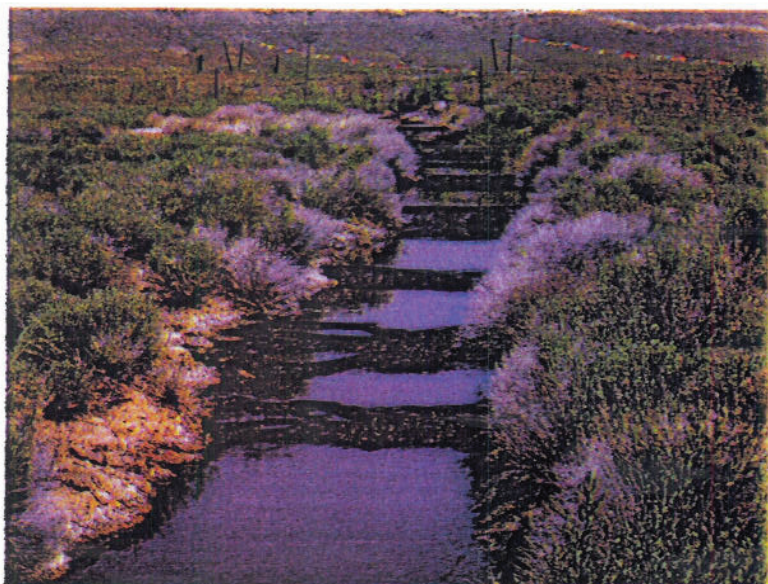
This site is tentatively classified as a Rosgen C, precip. terr., and is dominated with precipitation terraces and precipitation covered sapropel black ooze deposits. This segment needs to have a toxic chemical screen done to see if the high selenium value of 47 ug/l that was discovered downstream comes from the NPDES discharge. The self monitoring data shows a steadily decreasing TDS since June of 1997 (9,030mg/l) to a value 5750 mg/l in 2004. This still exceeds the limit of 5,000 mg/l.

Ph11.5-1: This section is dominated by precipitation terraces that remind one of Yellowstone National Park on a small scale. The water is not hot however and was recorded at 69 degrees F in the field notes.

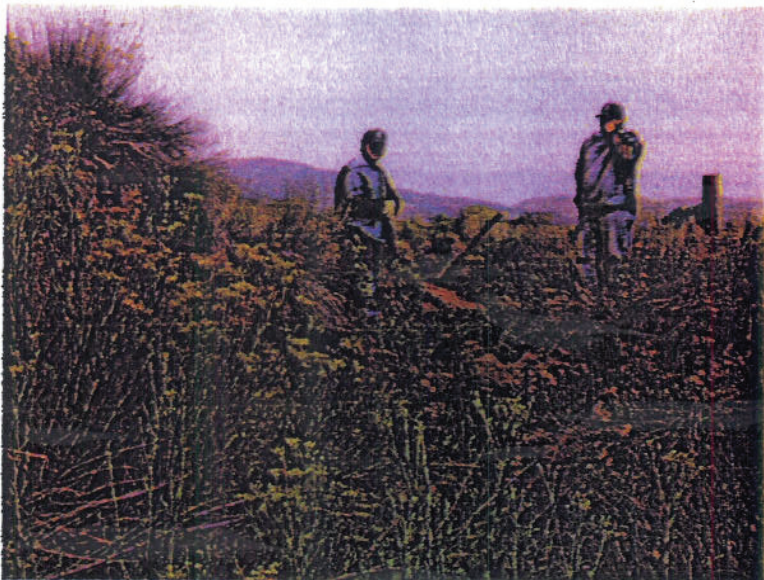
This site is tentatively classified as a Rosgen G-4, and is produced water dominated. The stream cascades down the gully in a series of drops and pools. Macrophytes including sedges and cattails were present. The potential non-supporting status comes from the high TDS at 6,890 mg/l and the high selenium values at 47 ug/l. Selenium is a bioaccumulator with a recommended chronic life criterion of 5ug/l.

The dissolved oxygen at this site was very high at 10.35 mg/l. This is probably due to photosynthesis of the macrophytes that were observed and the incorporation of atmospheric oxygen in the steep drops that occur in the gully. Long nosed dace were collected as well as a fairly rich macroinvertebrate fauna with 20 species. High species diversity does not necessarily mean that this water is safe for other uses. Bioaccumulation effects often don't occur until higher in the food chains and with larger organisms such as birds and mammals. Selenium is a sulfur mimic and gets incorporated in proteins, especially in the protein keratin which makes up; hair, hooves and nails. Brittle hair and deformed hooves are some of the first signs of chronic selenium poisoning.

Ph12-1: Dean and Travis on the edge of the eroded gully.

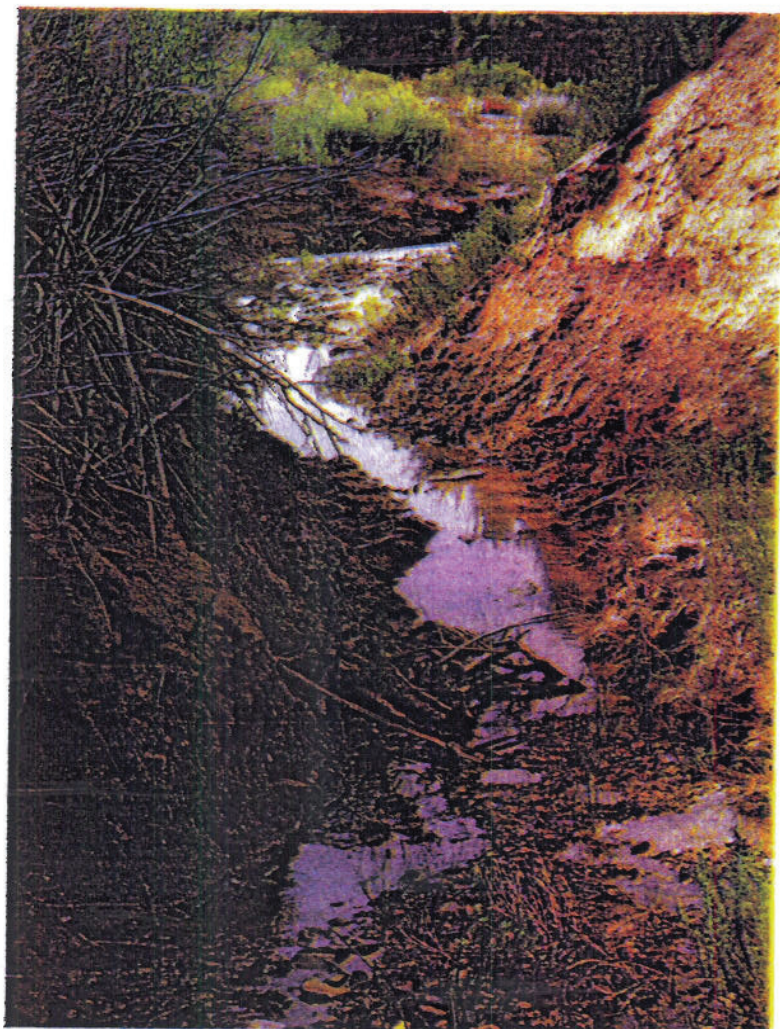
Ph12-2: The stream is entrenched in a steep gulley and was tentatively classified as a Rosgen G4. The steep drops and the presence of macrophytes added much oxygen to the water. The high selenium values need to be confirmed and the sources of the selenium need to be determined.
